WTCI-12-P

PROPERTY CONDITION ASSESSMENT
OF
WORLD TRADE CENTER PORTFOLIO

CENTRAL PLANT

Re: Due Diligence Physical Condition Survey
World Trade Center
New York, New York

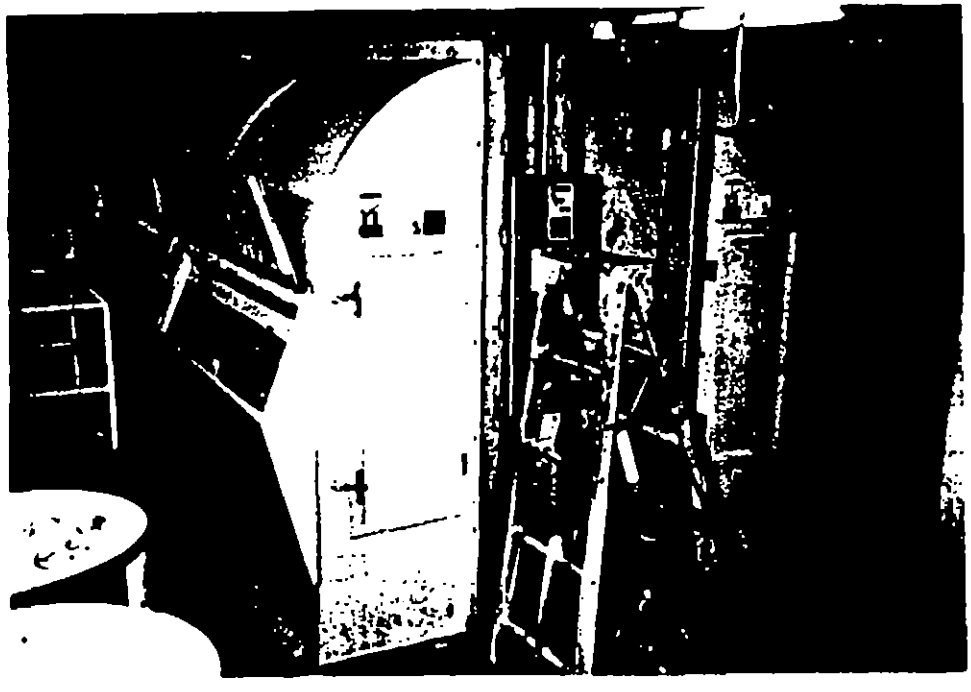
Photograph 1

River water pumps in the remote pumping station

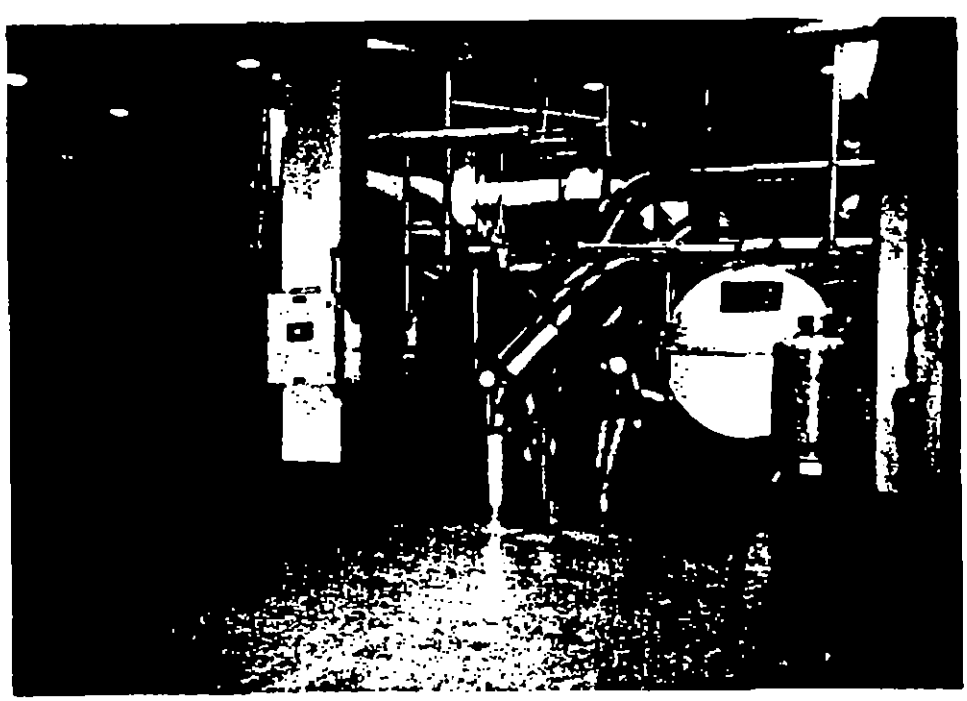
Photograph 5

Main chiller #3

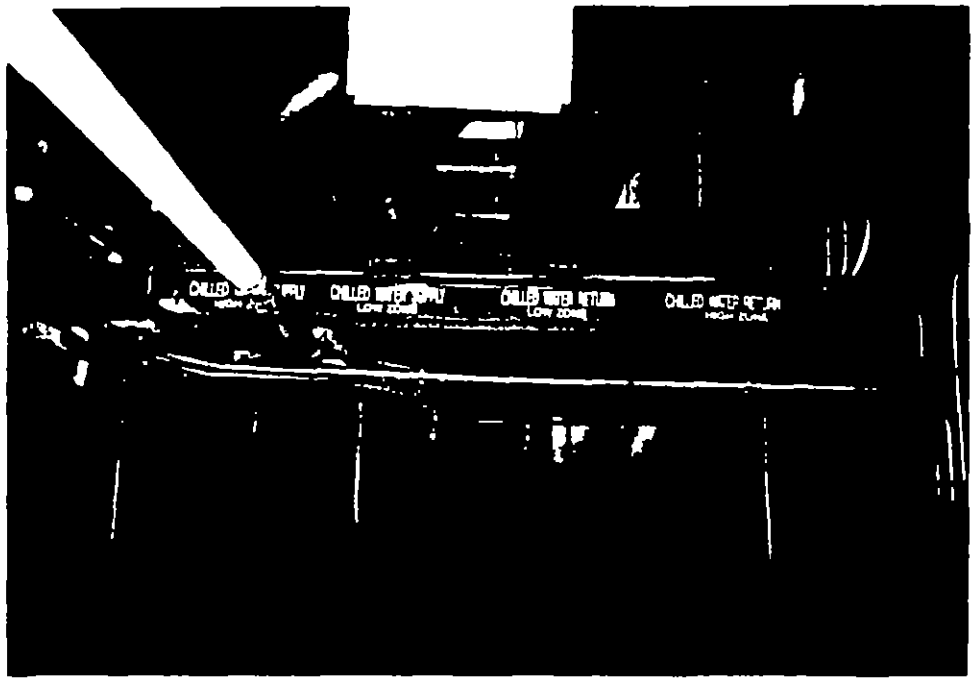
Photograph 7

Chilled water pumps

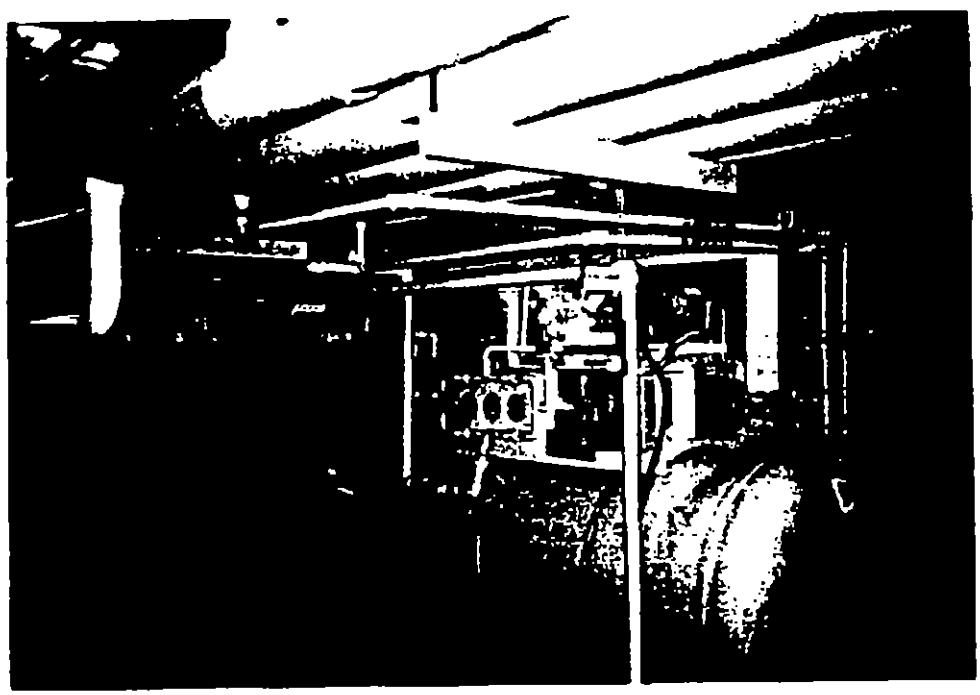
Photograph 9

Supplemental chillers

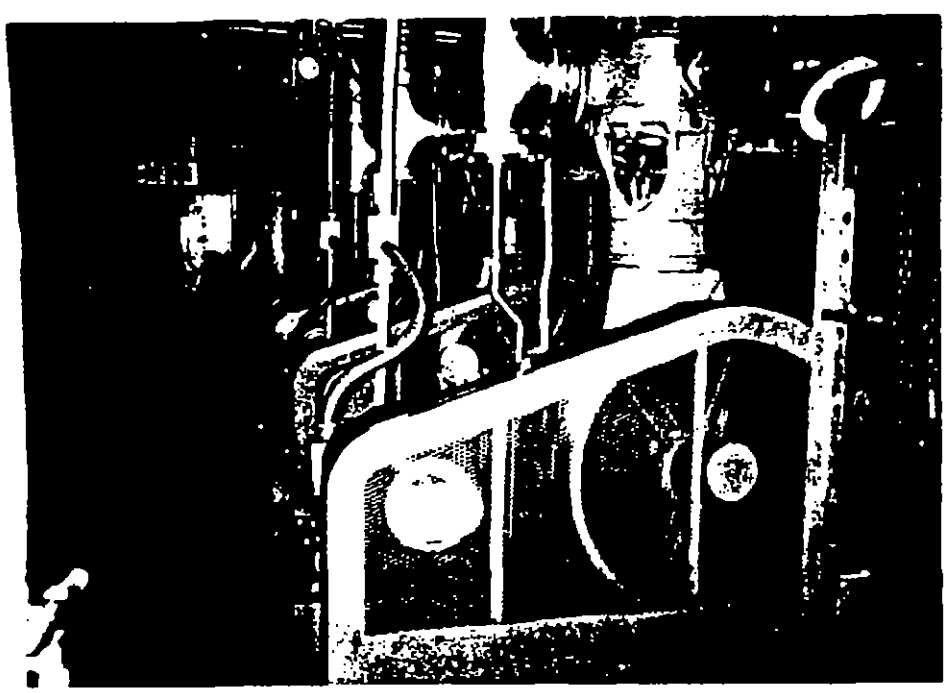
Photograph 11

Heat exchanger for economizer operation

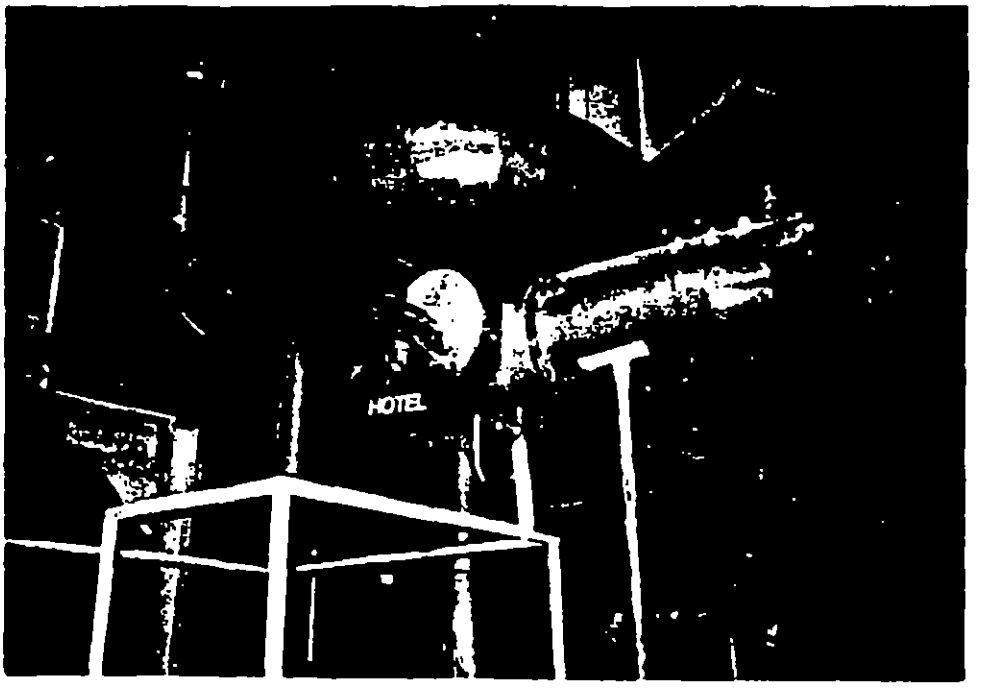
Photograph 14

Steam service valve (planned for replacement)

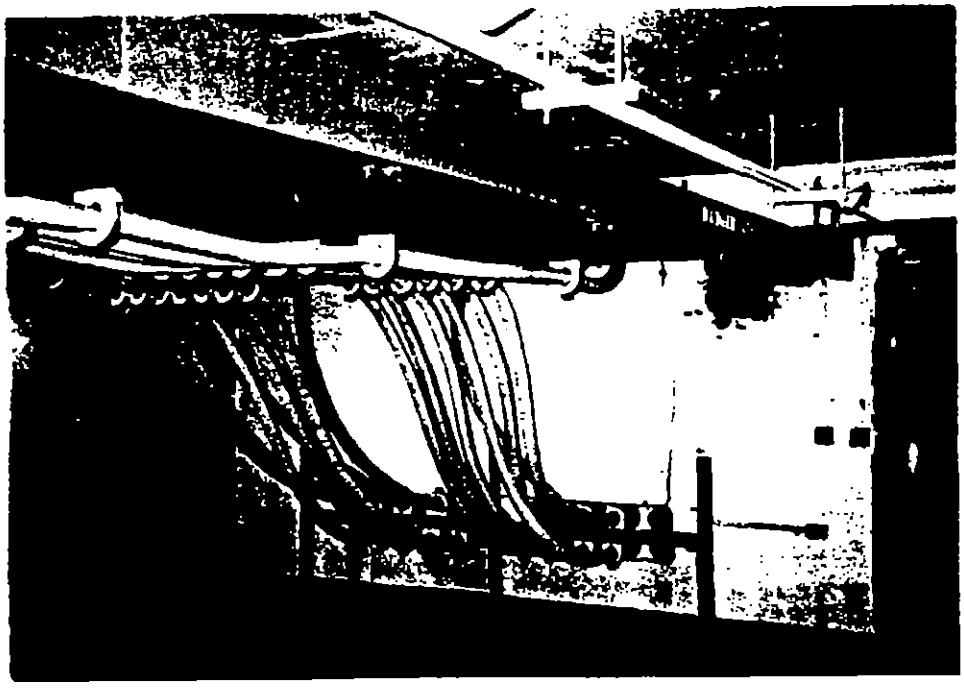
Photograph 17

Switchgear within the Primary Distribution Center

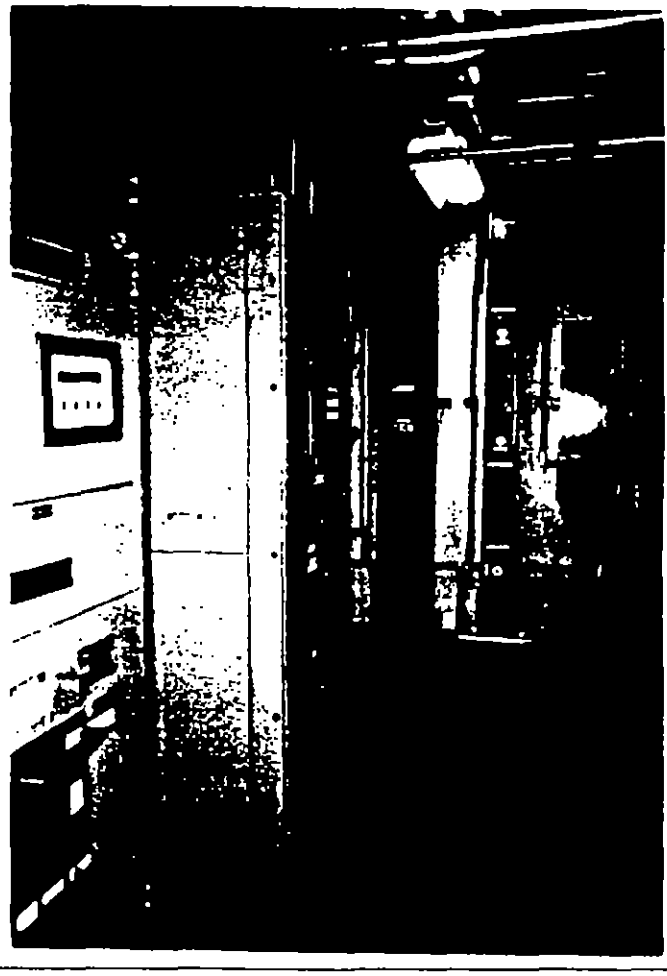
Photograph 19

Upgraded electrical substation
